PROPERTY CONDITION ASSESSMENT
OF
WORLD TRADE CENTER PORTFOLIO

FIVE WORLD TRADE CENTER

FINAL DRAFT

**REPORT OF
DUE DILIGENCE PHYSICAL CONDITION SURVEY
WORLD TRADE CENTER**

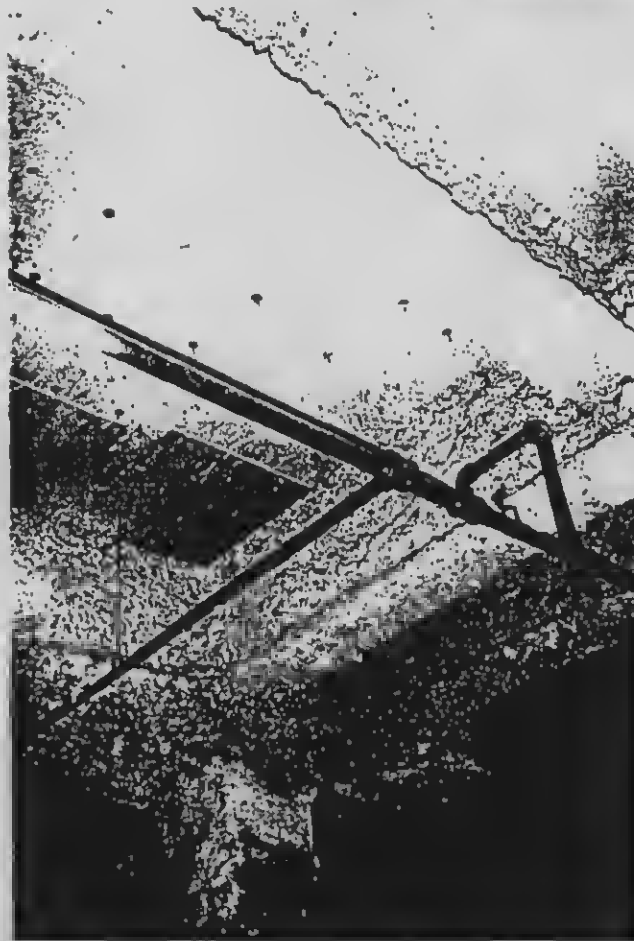
Photograph 2

Existing
structure at 8th
floor below the
MER. Spray-
applied
fireproofing and
rigid panel sound
insulation are
visible

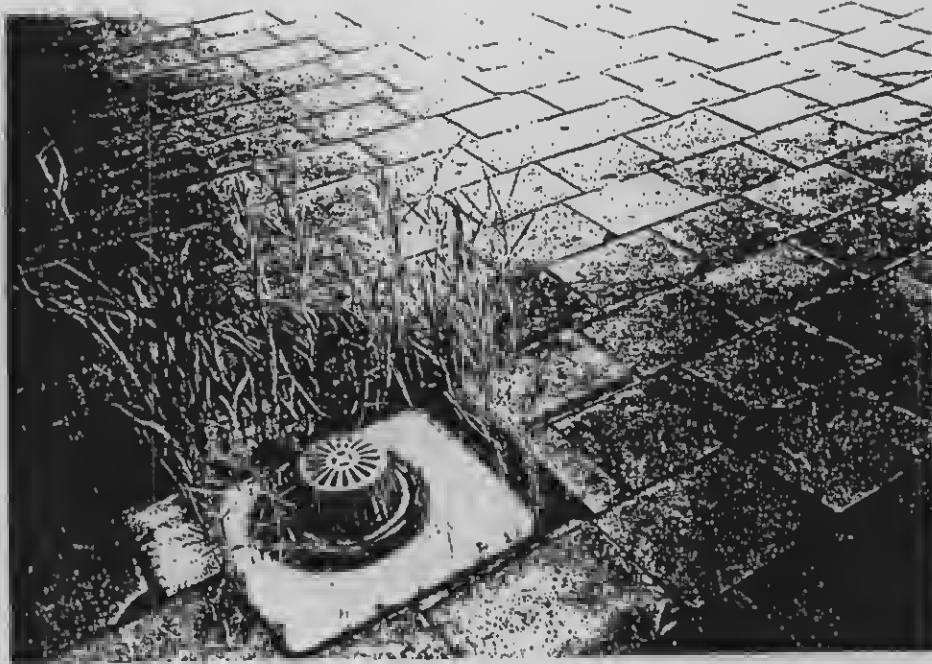
Photograph 13

Detail of roof
drain with
vegetation
growth
supported by the
moisture held in
paver backing

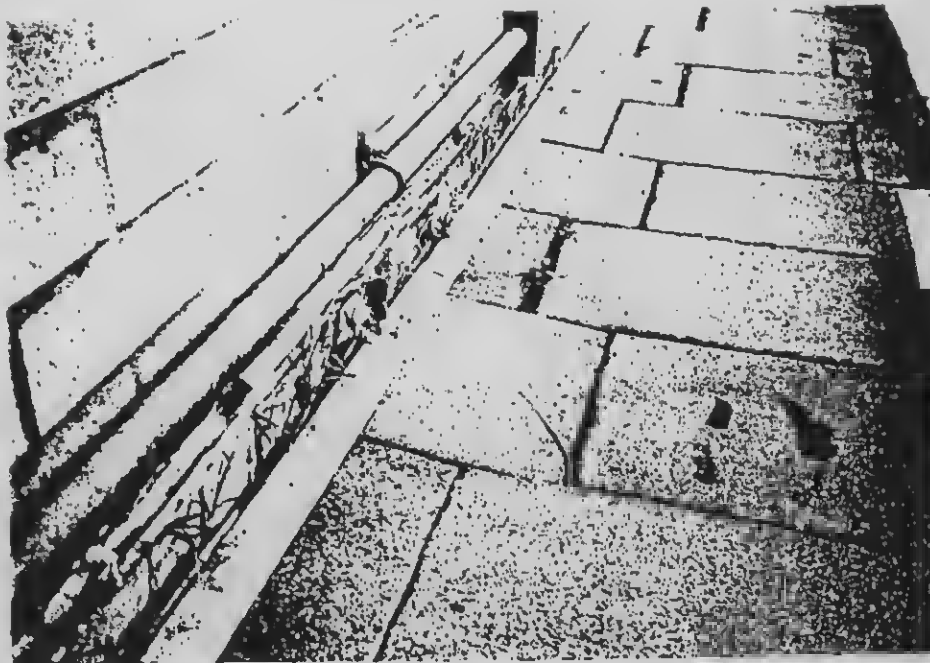
Photograph 14

Detail of
perimeter
flashing detail
with vegetation
growth

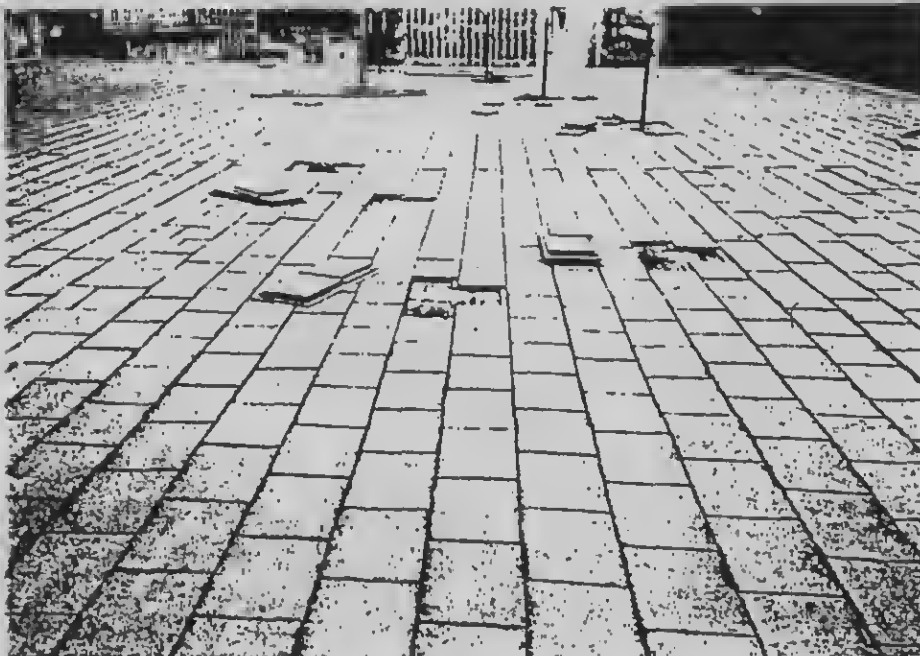
Photograph 15

Penthouse roof
with pavers
removed for
patching of
membrane
